AN EXPERIMENTAL ANALYSIS ABOUT THE FRACTURE OF THE WHEELSET-AXLES OF THE 5100 KW ELECTRIC LOCOMOTIVE

The paper is focused on some experimental analysis performed in the Testing Materials Laboratory belonging to I.C.M. Resita regarding the appearance of cracks in the wheelset-axles of the 5100 kW electric locomotives. Chemical, traction, bending dynamic and torsion tests are performed for different wheelset-axles, different rolling distances and different working conditions which for the "stick-slip" phenomenon occurred.

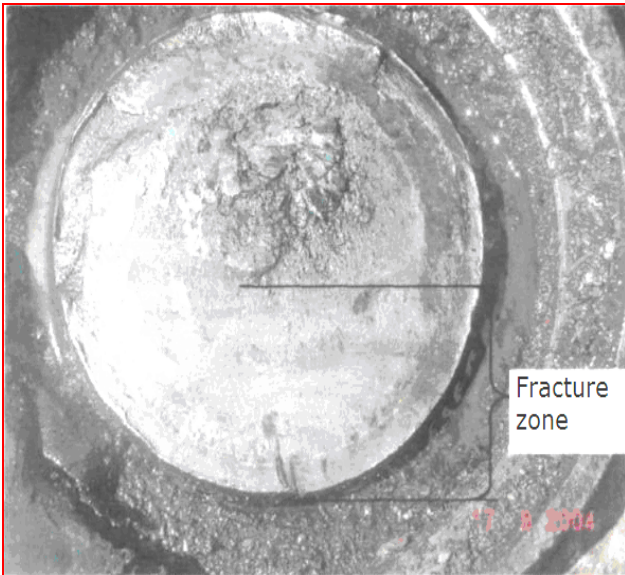
The aspect of the cross-section fracture zone represents the main juridical factor when a wheelset-axles accident takes place. The shiny zone parts (figure 1) represent the fatigue area inside where the cracks grow in time.

Figure 1. The aspect of the fracture zone in the body of the wheelset

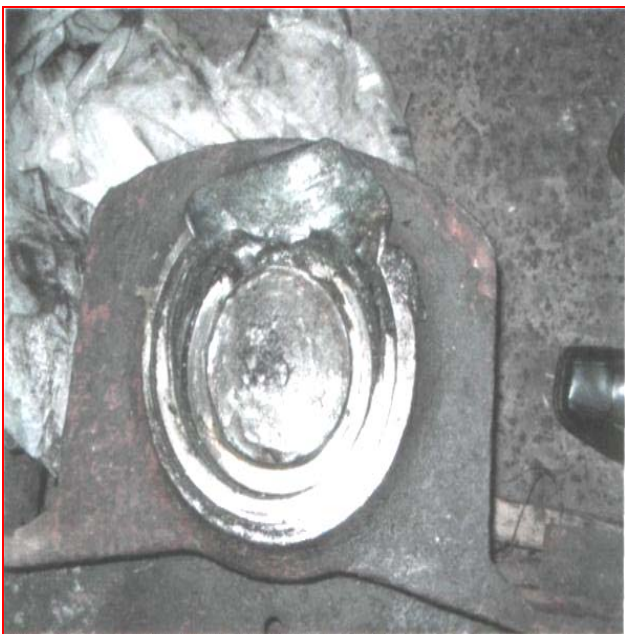
Figure 2. The aspect of the fracture zone in the extremity of the wheelset (lubrication boxes)
