## ETHYLENE PYROLYSIS FURNACE TUBE DAMAGE INSPECTION

**Abstract:** This aim of this study is to identify failure mechanism of ethylene pyrolysis furnace tube after five year of operation. The tubes were manufactured from centrifugally cast heat resistant steel HK 40. Failure analysis of the radiant tubes was performed by careful visual inspection of the failed tubes, scanning electron microscopy observation of crack region samples, hardness and micro-hardness measurements. Selected specimens were prepared from the four samples, measurements was carried out at inner, middle and outer sides of the samples. The experimental results showed that the mode of tube failure was a combination of high temperature carburization attack and creep damage leading to intergranular cracking. Maximum hardness is associated with internally carburized zone where the amount of carbides is maximum in this region. The hardness of the radiant tubes decreases as the distance moves from the inner surface to the middle section. The metallurgical background of the combined action of carburization and creep ductility exhaustion have been investigated and are explained. Pyrolysis tube failures can be prevented

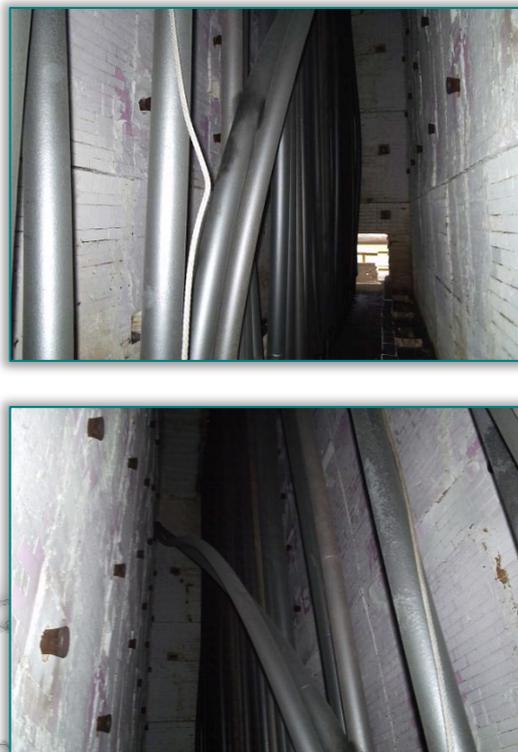
rate is the need to shut down the furnace and to shorten the coils (some end-users have lowered to bottom floor). Failures can occur if tubes are not shortened before they reached the heater floor (figure 2). The coils are warped and bowed, resulting in higher tube stresses and creep rates.

Figure 2. Pyrolysis furnace radiant zone – consequence of a high creep rate

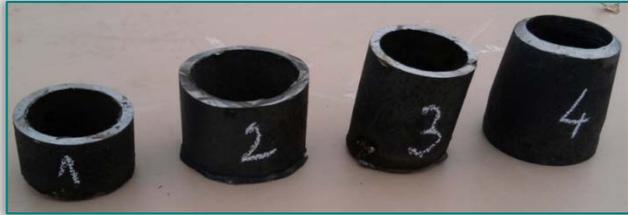
Samples (figure 3) were machined from the as-received tube section for evaluation, one unused piece, one used but not cracked piece (one year in use), one piece

showing sagging and different degrees of cracking (five year in use) and one piece which was not sagged but contained cracks (five year in use) at the inner surface that did not penetrate the entire thickness. Cutting was performed by using a precision sectioning machine with direct water-cooling of the specimen.

Figure 3. As received samples

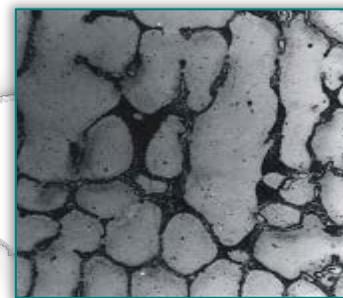
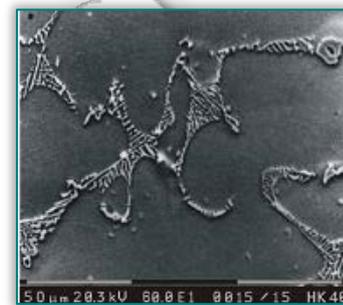
Microstructure of the samples from the tubes analyzed by optical microscope and scanning electron microscope. The microstructure of as-cast HK40 alloy consists of an FCC gamma matrix and a cellular structure, which involves  $\text{M}_{23}\text{C}_6$  carbides on the dendrite boundaries (Figure 4).

Figure 4. As-cast structure of the alloy HK40,

a.) optical - x 150, b.) sem - x 600

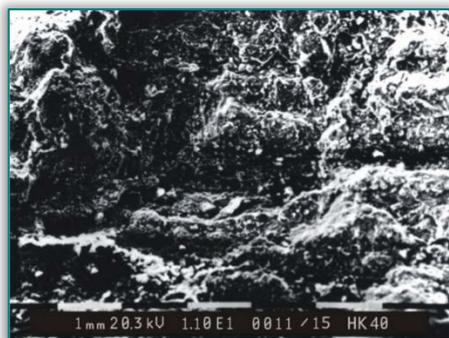
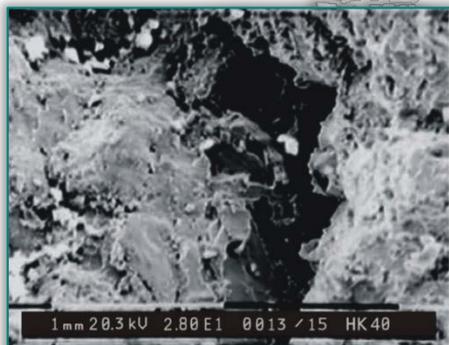
Figure 5. SEM images of sample 3 - a.) Surfaces with crack extended along dendrite grain boundaries – intergranularly, b.) Area with the presence of secondary cracks

The results of the fractured surface analysis presented in figure 5 could be used for explanation of the fracture initiation and propagation mechanisms. The fracture was initiated on oxidation/corrosion products from the inner side of the tube wall. The crack propagates intercrystally, i.e. along the grain boundaries of fine dendrites. Secondary cracks were also identified.

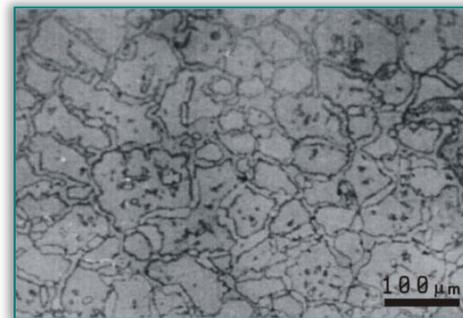
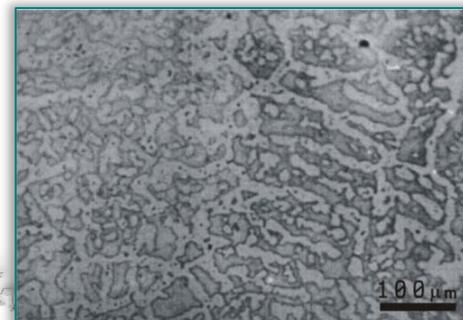
In sample 3, the volume percent of carbides varied across the tube cross-section (fig. 6), gradually increasing from the outer to the inner surface, being 36.2% and 44.7%, respectively. Sample 3 also contained, unlike sample 2, circular intra granular carbides in addition to a macrocrack.

Sample 3, which had been removed from the same furnace as sample 4, showed more severe microstructural degradation to approximately Stage IV in the model of Petkovic-Luton and Ramanarayanan [5].

In both samples, the carbides appeared to have coarsened and become continuous along the grain boundaries during service. This was more pronounced in Sample 3, suggesting that it had experienced more carburization than Sample 4.

Figure 6. Light micrographs from areas beneath: (a) the inner and (b) the outer surfaces of sample B.
