<sup>1</sup>Beata HRICOVÁ, <sup>2</sup>Ervin LUMNITZER, <sup>3</sup>Miriama PIŇOSO VÁ

## THERMOGRAPHY – TOOL FOR ASSESSING LIFE OF PRODUCTS

<sup>1-3</sup>Technical University in Kosice, Faculty of Mechanical Engineering,  
Department of Process & Environmental Engineering, Kosice, SLOVAKIA

**Abstract:** The paper is focused on the usage of thermography to assess the life of products and their failure rate. Thermography was used during routine vehicle technical inspections at the MOT station and focused on exhaust systems of 6 vehicles. For each vehicle tested, thermography identified critical places which, however, did not reduce the effectiveness of the product. The paper details the critical places of 2 cars. Potential damage has been identified in the 2 vehicles, as evidenced by increased values of emitted heat. As the results show, thermography is a suitable tool for identifying the quality reduction in the materials used, thus prolonging the life of the product thanks to early detection of problems.

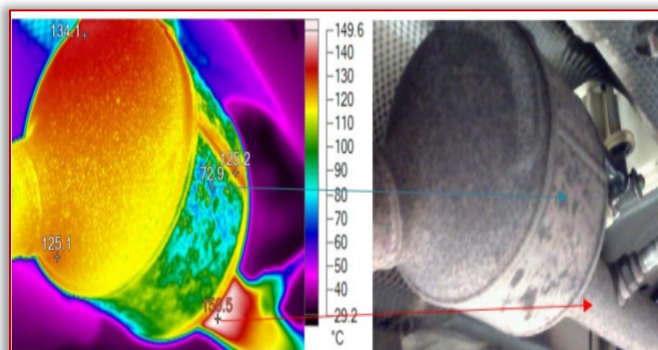
Figure 2. Infrared image of the exhaust system and real shot of the exhaust system

Of the listed and evaluated vehicles we focus only on 2 which thanks to thermographics showed thermal loss points caused by the extended corrosion of the exhaust system. The first of these was DACIA Logan. The thermogram showing the critical places is shown in Figure 2 and thermal limits of the marked places are shown in Table 7.

Title	Temperature	Emissions	Environment
Warm	150,5°C	0,92	18,0°C
P0	72,9°C	0,92	18,0°C
P1	134,1°C	0,92	18,0°C
P2	125,1°C	0,92	18,0°C
P3	125,2°C	0,92	18,0°C

This exhaust system shows that corrosion has disturbed the original properties of the material to such an extent that its quality is already reduced. This is manifested by large temperature differences between the individual parts of the exhaust system. Temperatures on the thermogram range from 45 °C to 160 °C. Figure 2 shows the difference between

the highest and lowest temperature of the evaluated surface - up to about 90 °C.

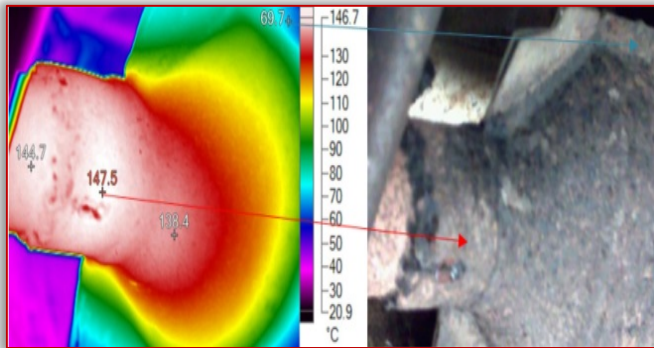
Figure 3. Infrared image of the exhaust system and real shot of the exhaust system

The second assessed vehicle was VOLKSWAGEN Polo Classic. The thermogram showing the critical places is shown in Figure 3 and the thermal limits of the marked places are shown in Table 8.

Title	Temperature	Emissions	Environment
Warm	147.5°C	0.92	18.0°C
P0	69.7°C	0.92	18.0°C
P1	144.7°C	0.92	18.0°C
P2	138.4°C	0.92	18.0°C

Since the car is 20 years old, it was evident that the individual parts of the exhaust system had been replaced. The replaced parts showed the average temperature of about 48-55 °C. The critical place, which is an original part, is shown in Figure 3, (the part has not been changed since the vehicle left the production). These places showed temperatures up to 177 °C. The reason is advanced corrosion and the evident reduction in the quality of the material due to its aging.
