¹Silva LOZANČIĆ, ²Davorin PENAVAL, ³Mirjana BOŠNJAK KLEČINA, ⁴Aleksandar JURIĆ

A CASE STUDY ON INFLUENCE OF TRAFFIC-INDUCED VIBRATIONS ON BUILDINGS AND RESIDENTS

¹⁻⁴Josip Juraj Strossmayer University of Osijek, Faculty of Civil Engineering and Architecture Osijek, Osijek, CROATIA

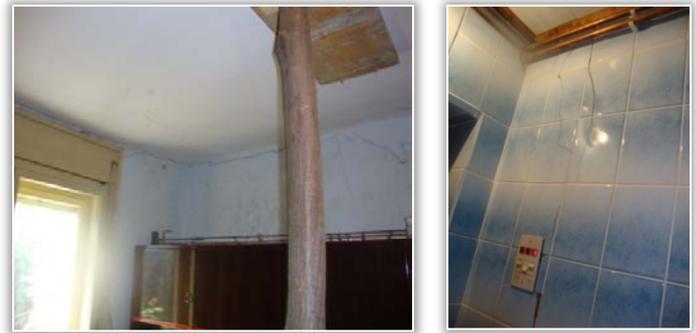
Presented are results for single building that suffered the most of the damage (see Figure 5). The building is a house with basement of dimensions 80 m², built in two parts (50 and 30 m²) with solid brick masonry without confining elements. The first, old part, was built 60 years ago, and second part was built several years ago. Due to age it is considered as sensitive building. The building is placed near road with 7 m distance to its closest point, and 19 m to its farthest. The foundation soil is rock. The building experienced both, the structural (collapse of storey slab in older part, cracks in outer and foundation wall) and the non-structural damage (cracking of windows, cracked ceramic tiles, displacement of roof tiles and rain water leakage).

Figure 5. Damage to the ceiling (left) and damage to the ceramic tiles (right)

The increased traffic, and correspondingly the vibrations, including the initial condition of the road, its surroundings, could have led to heavy damage to buildings. In other buildings, the damage level was lower, due to different input parameters.
