¹Hrvoje GLAVAŠ, ¹Zorislav KRAUS, ¹Zvonimir KLAJIĆ, ¹Stjepan KOČEVAR

REPLACEMENT OF FLUORESCENT LIGHT SOURCES WITH LED

¹Josip Juraj Strossmayer University of Osijek, Faculty of Electrical Engineering, Computer Science and Information Technology Osijek, Osijek, CROATIA

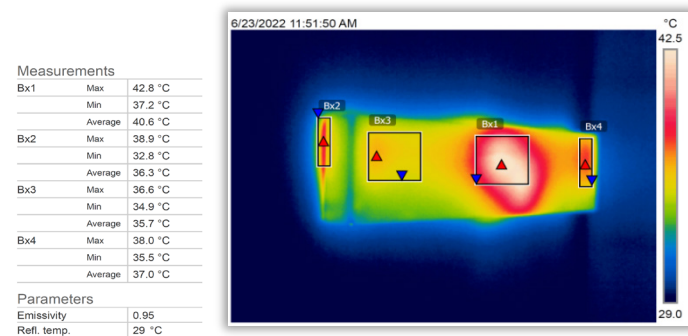
Motivation for this work was the failure (explosion) of the ballast of a FLU lighting fixture located in the cabinet 2-29 of the Faculty of Electrical Engineering, Computing Science and Information Technologies Osijek at the location Kneza Trpimira 2b. The lighting fixture was installed in 1995 as part of the modernization of the lighting system. On average, the light sources (tubes) were replaced every 5 years, while a visual inspection did not reveal any problems with the ballasts (change in color of plastic or connector). On June 23, 2022, the room temperature reached 29 °C. The cabinet, which is protected from the sun by tree canopies, must be artificially illuminated according to EN 12464-1:2021, [4] so the lighting was in operation. An explosion occurred in one of the lamps, accompanied by smoke and unpleasant odor. Thermographic inspection shows the first three minutes of the event, which caused a short circuit and turned off the entire lighting system. Figure 3 shows the thermal pattern immediately after the explosion.

Figure 3. Thermal pattern immediately after ballast failure

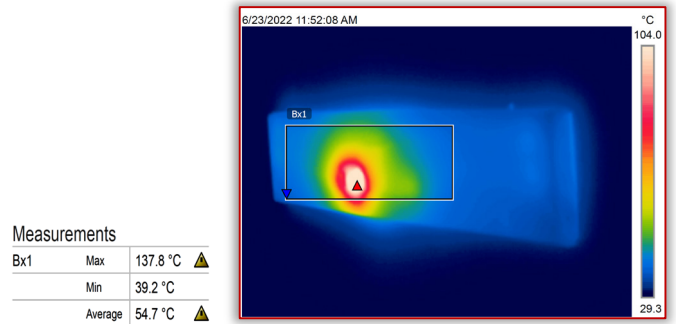
Figure 4 shows a piece of ballast that came loose and fell onto the diffuser of the lamp, causing the temperature to rise to 138 °C. After half a minute, another piece of ballast falls onto the diffuser, but

Figure 4. A piece of molten ballast falls on the base of the diffuser

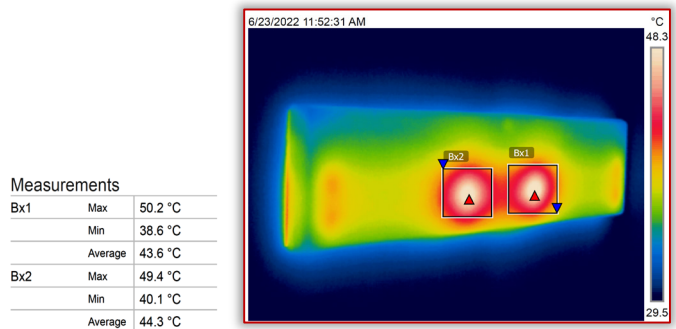
Figure 5. Two pieces of ballast on the base of the diffuser in gradual cooling

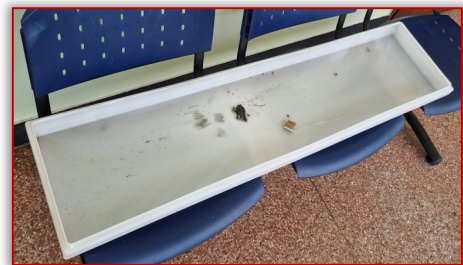
it cools quickly. By removing the diffuser, the cause of the short circuit and the extent of the damage could be determined (Figure 6 and Figure 7).

Figure 6. The diffuser of the lighting fixture and pieces of the plastic housing of the ballast previously observed by thermographic inspection

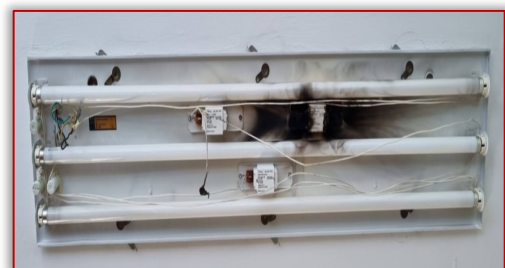
Figure 7. The extent of damage due to a short circuit of one of the ballasts A thermographic inspection of the ballast also revealed the limitations of the Flir 60bx infrared thermal imaging camera, which measures up to 150°C. The indicated temperature does pose a

After inspection, the entire lamp was turned off (not just the defective circuit) because the connecting conductors had insulation damage, as shown in Figure 7. The location of the defective lamp in the office is shown in Figure 9, and the affected lamp itself is highlighted by a red ellipse.

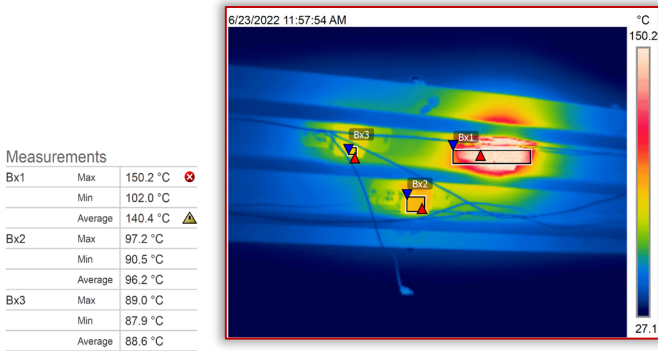
fire hazard, but due to the sheet metal support separated from the ceiling structure by joints and the design solution, the fire hazard is minimal. The approximate temperature of the other two ballasts can be seen in Figure 8 and is 90 °C.

Figure 8. Partial thermographic analysis due to the limited temperature range of the camera

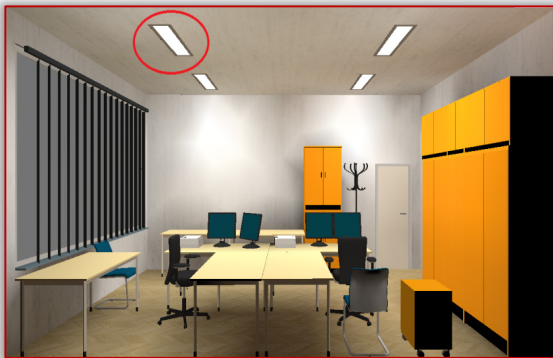
Figure 9. The location of the faulty lamp in the office

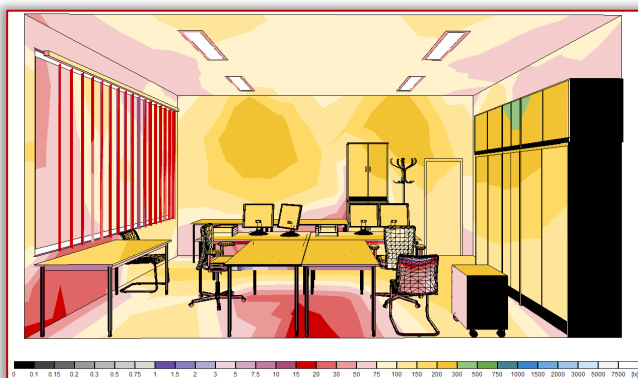
Figure 10. Analysis of the initial conditions assuming that all lighting fixtures are in operation

standard EN 12464-1:2021 Light and lighting - Lighting of work places - Part 1: Indoor work places. Figure 10 shows the situation where lighting levels on work surfaces do not exceed 300 lx. It was clear that simply replacing lamps was not the optimal solution.

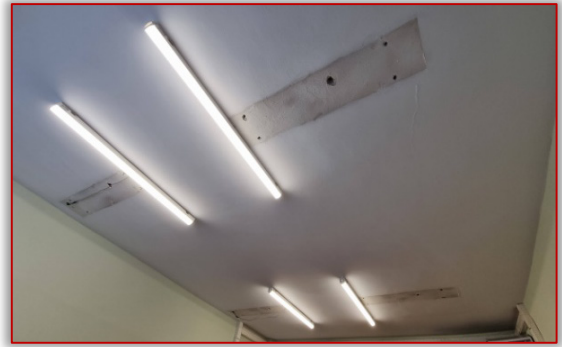
Figure 14. New LED lighting immediately after installation

The installation of the new lamps took a little more time because of the arrangement of the sockets and the painting of the ceiling. Figure 14 shows the ceiling immediately after installation. The installed power was reduced from 456 W ($4 \times 3 \times 38$ W) to 220 W (4×55 W). If the results of the simulations prove to be good, the tariff model shows that for an investment of 208.68 €, 635.96 kWh can be acquired at current market prices, which, based on an worst case scenario of 2000 working hours per year, gives a simple payback time of the investment of one year and four months (2695 hours). These figures are very reassuring, since the guarantee on the lamps is two years and the cash flow cannot assume a negative balance.

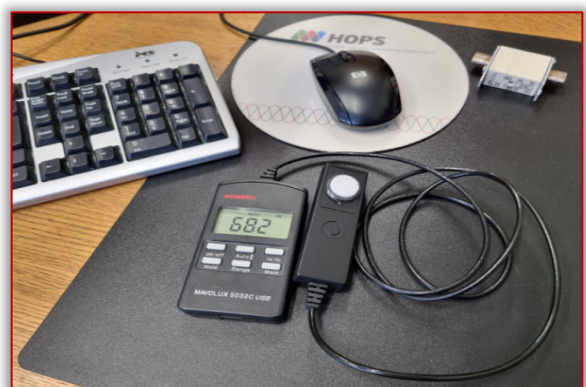
Figure 15. Comparison of the spectral response curve of the Mavolux luxmeter (black), the human eye (orange) and the spectrum of the LED white source (red), [9] Measurements at several points were used to determine the average values on the work surfaces, which ranged from 680 lx to 943 lx [10]. Figure 16 shows the measured value on the work surface of the table located at the site of the investigated defective lamp FLU.

Figure 16. Verification of model with lighting measurement
