TECHNOLOGY OF THE MINE WASTE WATER DISPOSAL

This study outlines the application of electrolytic waste water treatment use for mine works out flowing water. It describes history and circumstances in the 5 mine works (tunnels) in Spišská Nová Ves region. Finally the article provides results of the experimental treatment of the mine out flowing water with high percentage removal of Cr, As, Cu and Hg.

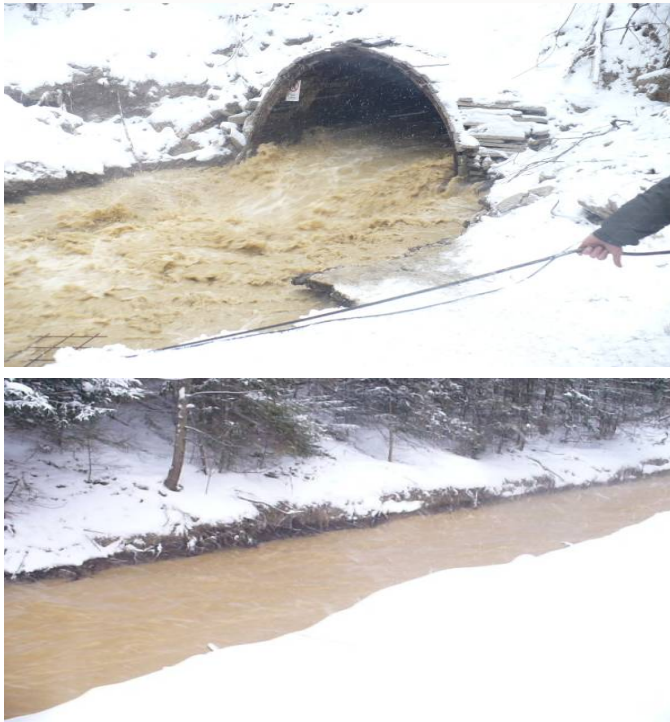
Figure 1 - Water outflow from Nová štôlna and view on the dirty stream

In the next procedure was anti breakage dam dimensioned for the water column of height 80 m. 17.2.2009 was fourth outflow of water from mining work Nová štôlna. Because of that event were suspended works on building an anti breakage dam. At this time is the dam already built. Monitoring borehole was realized. Because less water outflows, water in the borehole increases. [2] Photographic documentation of the site in question is captured on Fig. 1.

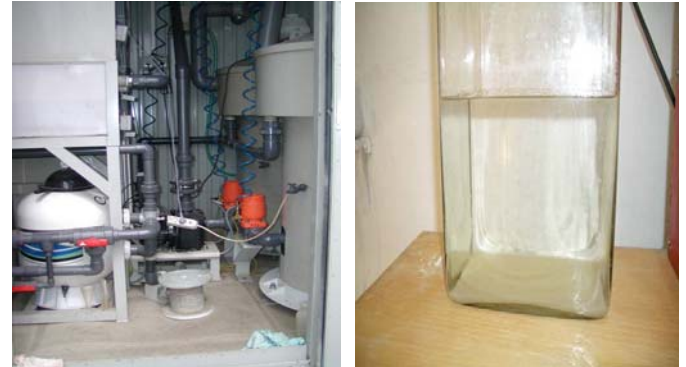
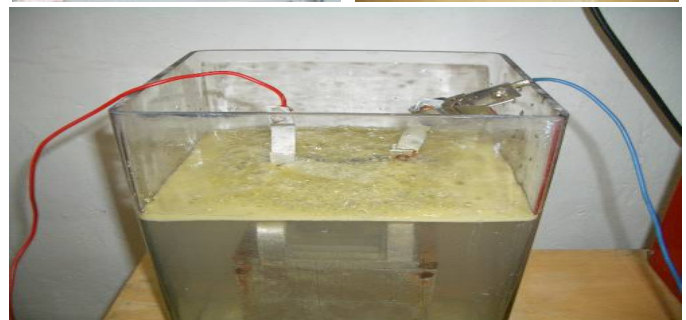
Figure 3 - Patented equipment (left) [4], laboratory flotation on the water sample (middle) and water after electro flotation (right)

Laboratory experiments were realized in laboratory electrolyzer with capacity 8 l at the following conditions:

- Electrolyzer capacity: 8 l
- Sample capacity: 5 l
- Number of electrodes: 7 pcs
- Distance between electrodes: 4 cm
- Electrodes size: 100x100x2 mm
- Electrodes arrangement: Fe-Al-Al-Fe-Al-Al-Fe

Photo documentation from laboratory measurements is captured on fig. 3.

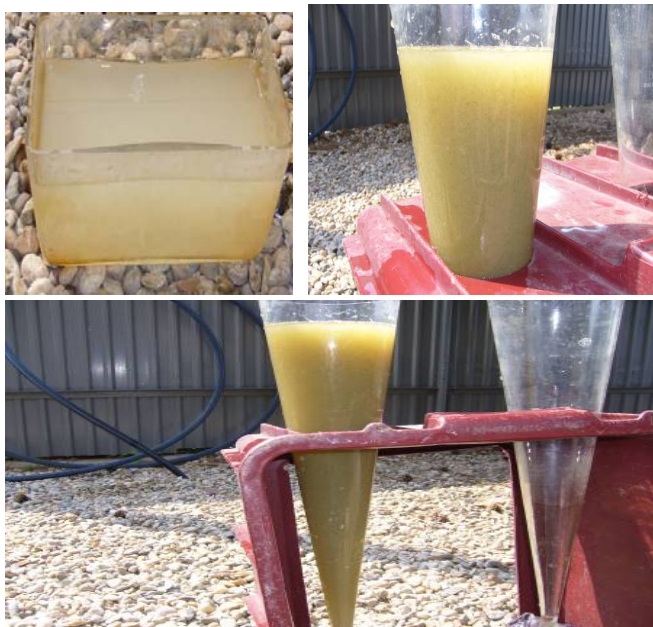
Figure 2 - Sampling scoops

Electrolyser was filled with 5 liters of mine water and the current was turned on. The electrolysis was interrupted after eight minutes and the content was transferred to the sedimentation barrel. After sillage (25 - 40 min.) was the mud drained and pure solution was transfused to the sampling scoops (fig. 2)
