¹Hrvoje GLAVAŠ, ¹Zorislav KRAUS, ¹Zvonimir KLAJIĆ, ¹Stjepan KOČEVAR

REPLACEMENT OF FLUORESCENT LIGHT SOURCES WITH LED

¹Josip Juraj Strossmayer University of Osijek, Faculty of Electrical Engineering, Computer Science and Information Technology Osijek, Osijek, CROATIA

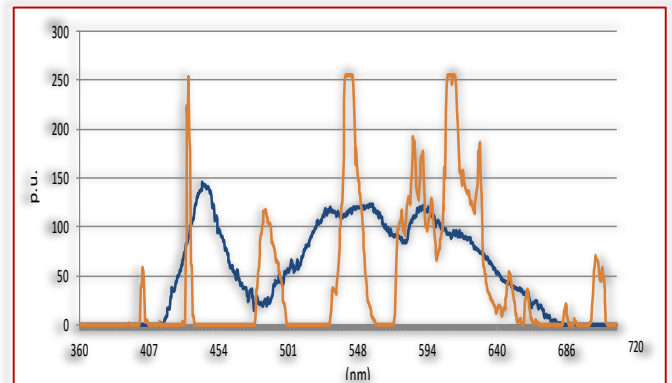
Another benefit of replacing FLU with LED is seen in the potential reduction of the characteristic 100 Hz flicker of FLU, but also in the significant increase in color rendering index due to the richer spectral composition of the LED source. In Figure 11, the spectral composition of the LED illumination is represented by a blue curve, while the spectrum of the FLU illumination is represented by an orange curve [5]. The spectrometer used for the analysis of light sources for the purpose of this paper is SPECTRA 1, manufactured by Kvant [6].

Figure 11. Comparison of the spectral composition of LED (blue) and FLU light source (orange)

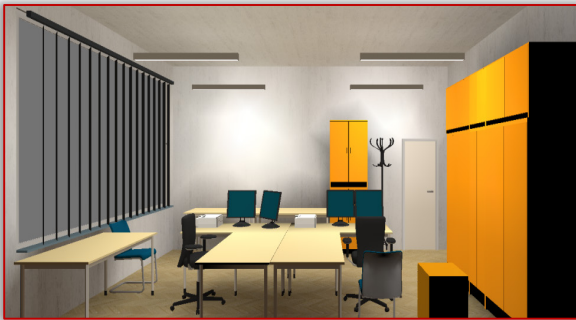
Figure 12. Lighting system model with new Solo LED 55 W lamps

decided to make a first analysis with the Schrack lamp Solo LED 1 × 55 W 6000 lm, [8], price 52,17 €. The model of the system with new lamps is shown in Figure 12, while the illumination values can be seen in Figure 13.

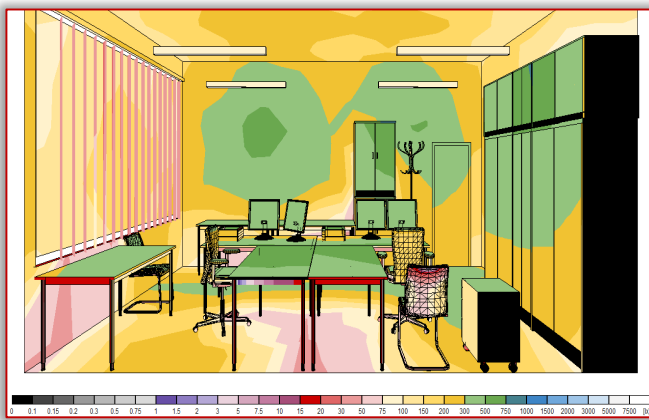
Figure 13. Results of surface illumination using Solo LED 55 W lamps

The analysis of the data obtained from the simulation shows that the new scene proposal provides values that comply with EN 12464-1:2021 and that the luminous flux of 6000 lm per lamp meets the needs of the users of the room with an illuminance of 500 lx to 750 lx on the work surface.

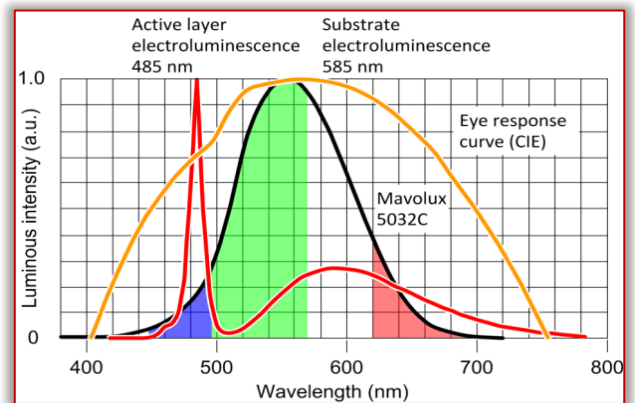
Figure 15. Comparison of the spectral response curve of the Mavolux luxmeter (black), the human eye (orange) and the spectrum of the LED white source (red), [9] Measurements at several points were used to determine the average values on the work surfaces, which ranged from 680 lx to 943 lx [10]. Figure 16 shows the measured value on the work surface of the table located at the site of the investigated defective lamp FLU.
