1. Ištvan KUCORA, 2. Ljiljana RADOVANOVIĆ

## PYROLYSIS FURNACE TUBE DAMAGING AND INSPECTION

**Abstract:** This paper explain the most occurring failure mechanisms for pyrolysis furnace radiant tubes. Basic damaging mechanism is the combined action of carburization and creep ductility exhaustion. This results in bulging, bending and ovalization of the tubes. The second dominant failure mechanism is brittle fracture during furnace trips, which can result in large, longitudinal cracks on many tubes. There are several methods for estimating and damage detection of furnace tubes. In assessing the state of furnace tubes we use an optimal combination of methods, as individual methods cannot detect any potential damage. The methods are related to the assessment of damage due to creep, and the material carburization which underlying the creep.

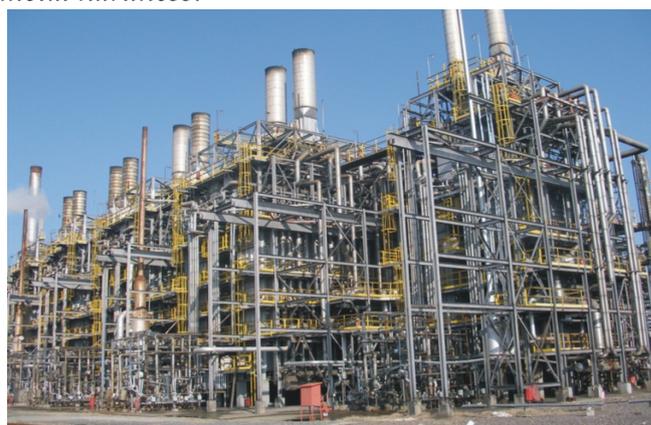
Figure 1. Pyrolysis furnaces in ethylene plant

Pyrolysis coils in ethylene cracking furnaces (Fig. 1) are exposed to very severe conditions, e. g. high temperatures up to 1150 °C, severe start/stop and decoke cycles, oxidizing and nitriding flue gases at the outside and carburizing atmospheres at the tube inside surface. Therefore, high-alloyed centrifugal cast Ni-Cr-Fe alloys with adequate high temperature corrosion resistance, good high temperature strength, good machinability and weldability (even after years of service) are required.

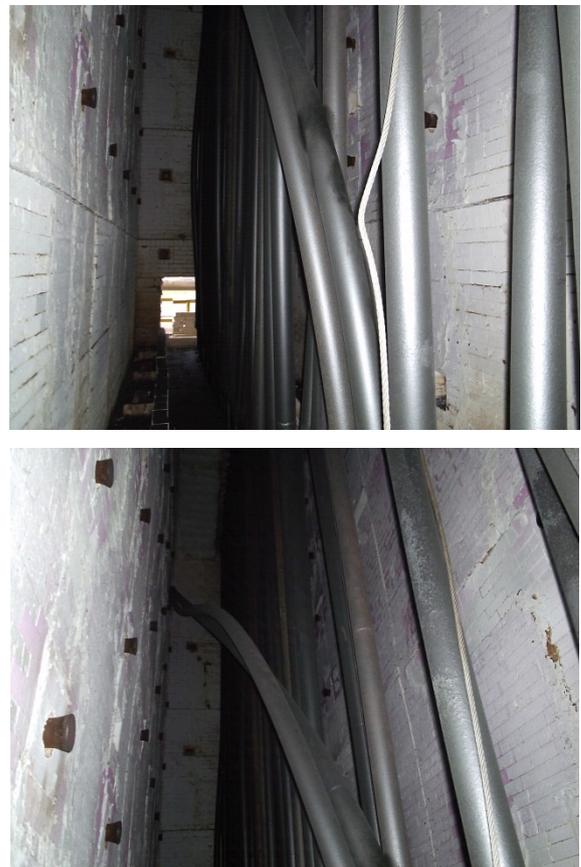
Figure 2. Pyrolysis furnace radiant zone - consequence of a high creep rate

Creep elongation (also called stretching) occurs because of creep by the self-weight of the tube and the coke layer present in the tube and is influenced by temperature, the load carrying cross section of the tube, and the material used. A consequence of a high creep rate is the need to shut down the furnace and to shorten the coils (some end-users have lowered to bottom floor). Failures can occur if tubes are not shortened before they reached the heater floor (Figure 2). The coils are warped and bowed, resulting in higher tube stresses and creep rates.
